AFRL-ML-WP-TR-1998-4191

**CUT PROGRESSION DURING DYNAMOMETER
TESTING OF FOREIGN OBJECT DAMAGED TYPE
VII EXTRA HIGH PRESSURE AIRCRAFT TIRES
SAE PAPER 912155**

SEPTEMBER 1991

**MATERIALS AND MANUFACTURING DIRECTORATE
AIR FORCE RESEARCH LABORATORY
AIR FORCE MATERIEL COMMAND
WRIGHT-PATTERSON AIR FORCE BASE OH 45433-7750**

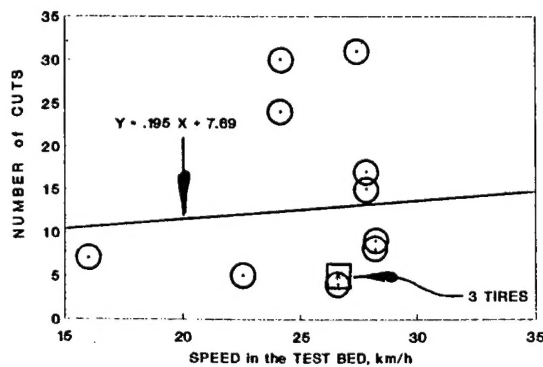
FIGURE 9: SPEED vs NUMBER OF CUTS
Recapped Tires

The number of primary cuts produced is presented in Figure 9, as a function of speed in the test bed at NAEC. Individual tires had between four and 31 primary cuts, with 69% of the tires having 15 or fewer cuts. The positive slope indicates that more damage was done as the NAEC speed increased.

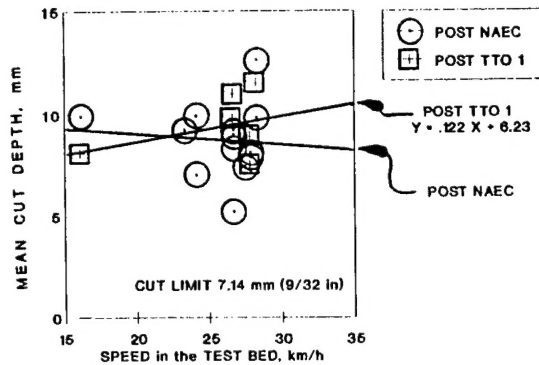
FIGURE 10: MEAN DEPTH OF PRIMARY CUTS
Recapped Tires

The mean depth of the primary cuts on each tire is presented in Figure 10. 54% of the tires were at or above the 7.1 mm (9/32 inch) Cut Limit. The negative slope results from the choice of tires. A different group might have had a different slope.

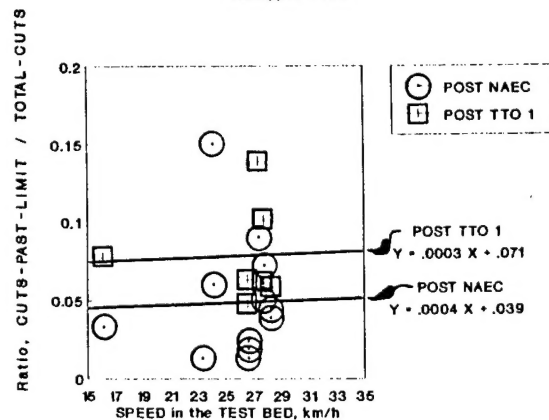
FIGURE 11: PAST LIMIT TIRE PERFORMANCE
Recapped Tires

The ratio of cuts deeper than the Cut Limit, to the total number of cuts is presented in Figure 11. Both the POST NAEC and POST TTO 1 curves have a positive slope and positive intercept. As above, the number of cuts deeper than the Cut Limit is worse with higher track speed. The POST TTO 1 curve is above the POST NAEC curve: more internal damage is revealed with additional dynamometer testing.

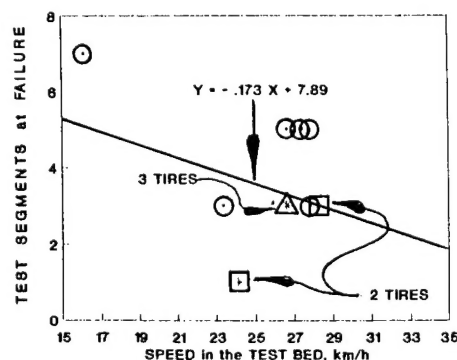
FIGURE 12: SPEED vs SEGMENTS at FAILURE
Recapped Tires

tire failure is presented in Figure 12. On the dynamometer, 69% of the tires failed on or before TTO 2, Test Segment 3. The negative slope indicates more damage occurred at higher track speed, which resulted in a shorter life on the dynamometer. This curve compliments the information in Figure 9.

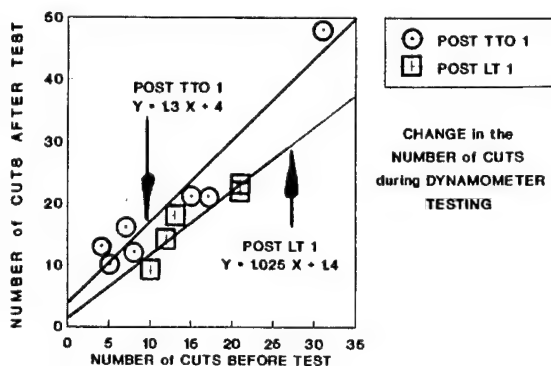
FIGURE 13: INCREASE in NUMBER of CUTS
Recapped Tires

Data in Figure 13 highlights the increase in the number of cuts with testing. The X-axis indicates the number of cuts before a dynamometer test segment; the Y-axis indicates the number of cuts after a dynamometer test segment. Each data point is an individual dynamometer run for an individual tire. The slope of the Post TTO 1 curve is 1.3; the intercept is 4.0. These suggest that there were an average 34% more cuts visible after the first dynamometer event than on return from NAEC.

The slope of the LT 1 curve is 1.025 with an intercept of 1.4: a 3.9% increase in the number of cuts occurred after LT 1. The increase was less than after TTO 1, but still positive, i.e. the number of cuts continued to grow. Were this trend to continue and the tire to survive, one might expect to see a cut or blemish for each impact. The tires did not, however, last long enough to produce as many cuts and/or blemishes as impacts.

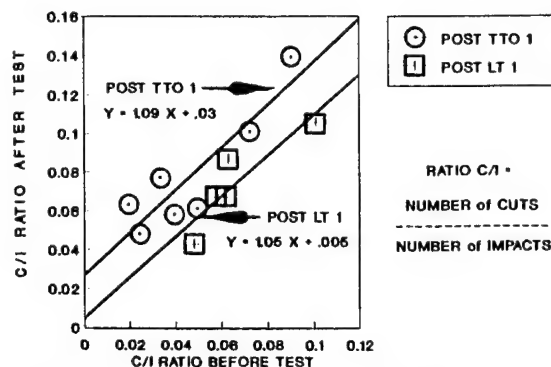
FIGURE 14: PERCENTAGE INCREASE in CUTS
Recapped Tires

On return from NAEC, a ratio, of the number of cuts to the number of the objects impacted, ranged from 1.3 to 15%. After TTO 1, the range narrowed to 4.8 to 13.9%; some of the tires were not remapped after TTO 1. After LT 1, the range was 4.4 to 10.6%. The numerical data from Figure 13 is presented as this ratio, in Figure 14. The curves show positive slope and intercept again. The TTO 1 curve is above the LT 1 curve.

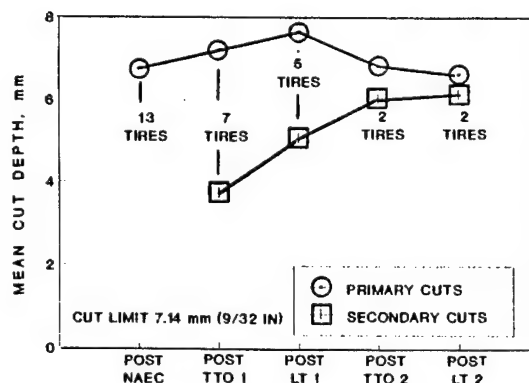
FIGURE 15: MEAN CUT DEPTH
Recapped Tires

The mean depth of primary and secondary cuts of all recapped tires is presented in Figure 15 and Table 4. It is interesting to note that the primary and secondary cuts have significantly different mean depths. The primary cuts are deeper. The trend in both is to deepen until the crack approaches the reinforced carcass.

The calculation is from a decreasing data pool as the tests progressed. The Post NAEC point is from 165 primary cuts on 13 tires where the Post LT 2 point is from 23 primary cuts on 2 tires.

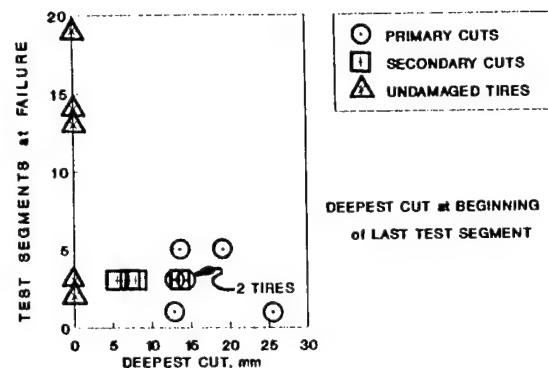
FIGURE 17: DEEPEST CUT at FAILURE Recapped Tires

The deepest primary and secondary cuts at the beginning of the last dynamometer test segment are presented in Figure 17. The primary cuts average 15.9 mm (20/32 inch) deep, more than twice the 7.1 mm (9/32 inch) Cut Limit. The secondary cuts average 7.9 mm (10/32 inch) deep which is just over the Cut Limit. As was noted above, 69% of the tires failed on or before TTO 2, Test Segment 3.

The average life of these 13 recapped tires on the dynamometer was 3.5 test segments. Operational field experience with the recapped tires was poor: fewer landings per tire change and more catastrophic failures than the new tire. A comparison test was completed using five undamaged

recapped tires. They were run on TTO schedules only. As noted in Figure 17, undamaged tires failed on segments 2, 3, 13, 14, and 19.

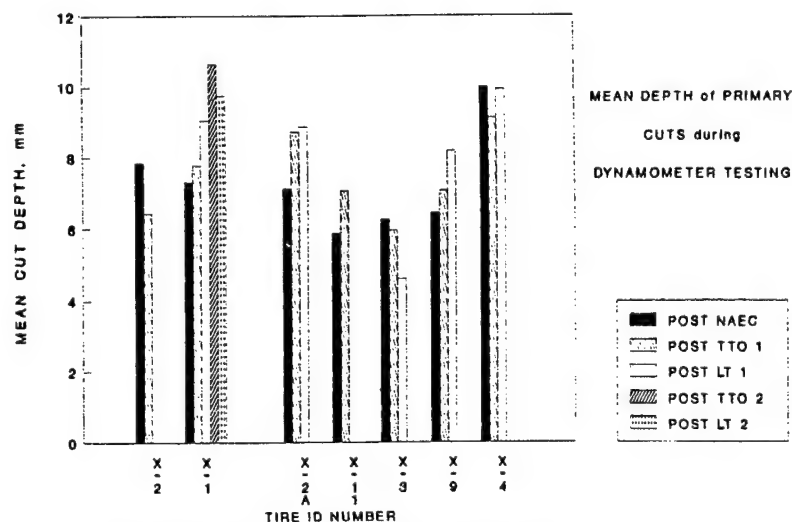
FIGURE 16: DEPTH CHANGES during TEST Recapped Tires

INDIVIDUAL CONDITION WITH TESTING - Changes in the mean cut depth of primary cuts of seven tires are presented in Figure 16. Damage is unpredictable. An increase or decrease in mean depth on one segment might be followed by the opposite after the next segment. The changes include the cut becoming shallower, deeper, or closing; new cuts appearing; or cuts going unchanged.

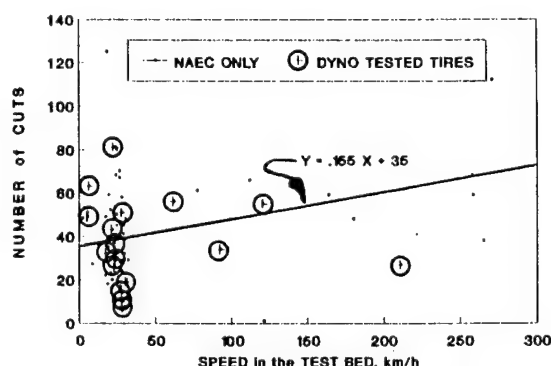
FIGURE 18: SPEED vs NUMBER of CUTS
New Tires

The number of primary cuts produced is presented in Figure 18. Dynamometer tires had between seven and 81 primary cuts, with 59% having 40 or fewer cuts. The trend noted with recaps is repeated: more cuts at higher track speeds.

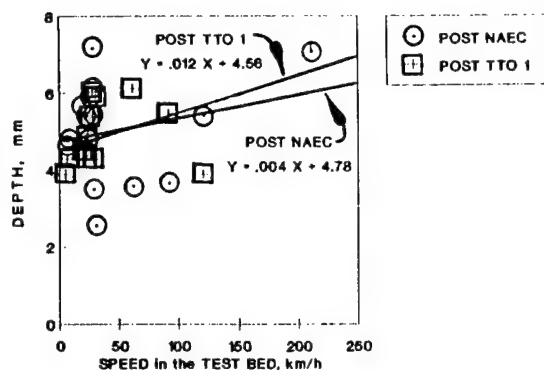
FIGURE 19: MEAN DEPTH of PRIMARY CUTS
New Tires

The mean depth of the cuts on each tire is presented in Figure 19. 35% of the tires were at or above the 5.6 mm (7/32 inch) Cut Limit. This compares to 54% of the recaps that were at or above a deeper Cut Limit. The initial mean depth of all cuts on all dynamometer tires was 4.9 mm (6.17/32 inch). This compares to 6.7 mm (8.5/32 inch) for the recaps. A Shore Type A durometer comparison of the new and recap tire materials may explain this difference. The recaps registered 10% lower value (softer compound). As was noted above, the service life of recaps was not as good as the new tires. Recaps F-16 main tires were removed from flight status.

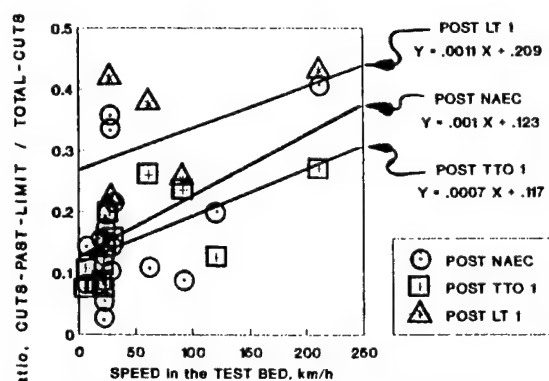
FIGURE 20: PAST LIMIT TIRE PERFORMANCE
New Tires

The ratio of cuts deeper than the Cut Limit, to the total number of cuts is presented in Figure 20. All three curves have a positive slope. The amount of damage is higher for the new tires than with the recapped tires, but the performance trend is reversed: POST TTO 1 data is below POST NAEC data. In a number of tires, the number of cuts dropped between NAEC measurements and POST TTO 1 measurements.

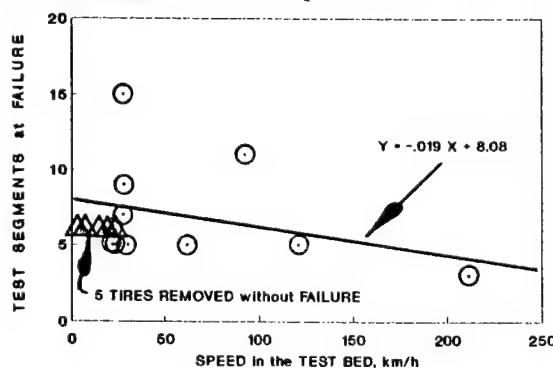
FIGURE 21: SPEED vs SEGMENTS at FAILURE
New Tires

The number of test segments run at tire failure is presented in Figure 21. On the dynamometer, 64% of the tires failed on or before LT 3, Test Segment 6. The negative slope of the curve compliments the information in Figure 12: more damage occurred at higher track speed, resulted in shorter life on the dynamometer. This is similar to the trend seen on the recaps.

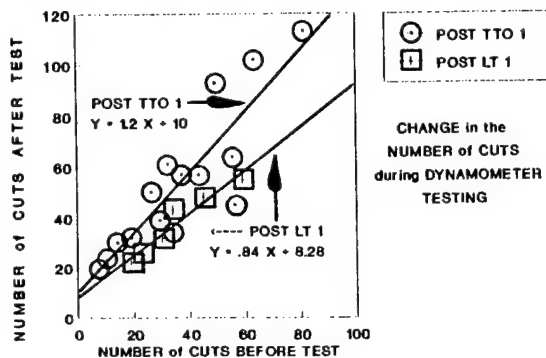
FIGURE 22: INCREASE in NUMBER of CUTS
New Tires

OVERALL CONDITION WITH TESTING - Like the recaps, the new tires deteriorated with each run on the dynamometer. The number of cuts before and after each test segment in Figure 22 is similar to recapped tire data in Figure 13, except that the slope and intercept are different. New tire POST TTO 1 data indicates a 30% increase in the number of cuts over POST NAEC levels; it was 34% for the recapped tires. New tire POST LT 1 data indicates an 8% decrease in the number of cuts over POST TTO 1 levels; it was a 3.9% increase for the recapped tires. A difference in tread material, noted with the Shore durometer test, may explain this change. On landing, the high heat created by spin up seems to temporarily glue some cuts back together.

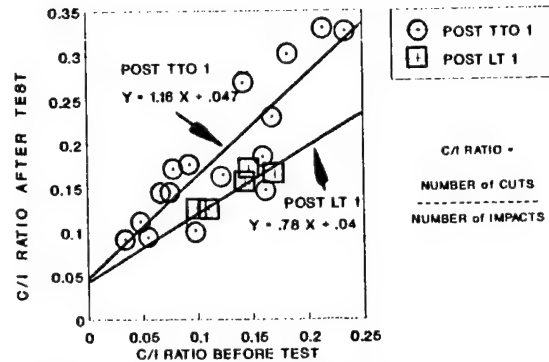
FIGURE 23: PERCENTAGE INCREASE in CUTS
New Tires

In Figure 23, the data from Figure 22 is presented as the ratio of cuts-per-impact before and after each dynamometer test. The slope and intercept of new tire POST TTO 1 curve is greater than it was for recapped tires curve. The new tire POST LT 1 curve has an 18% decrease over POST NAEC data; the recapped tire POST LT 1 curve had a 5.5% increase.

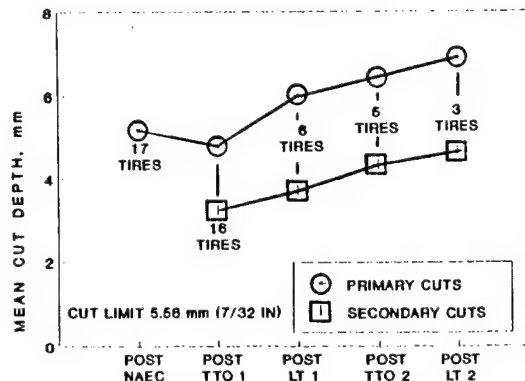
FIGURE 24: MEAN CUT DEPTH
New Tires

The mean cut depth of primary and secondary cuts of all tires is presented in Figure 24 and Table 5. The new tire trend is more severe than it was for the recapped tires: the mean cut depth increased above the Cut Limit with dynamometer tests. The data pool shrank as the test continued because of tire failures or removals after three TTO and LT segments had been completed.

The greater damage may also reflect the conditions of test at NAEC: twice as many new tires ran over 38 mm (1.5 inch) rocks than did recapped tires; and some of the new tires ran at "high" speed (above 48 km/hr - 30 mph), while no recap ran over 29 km/hr (18 mph).

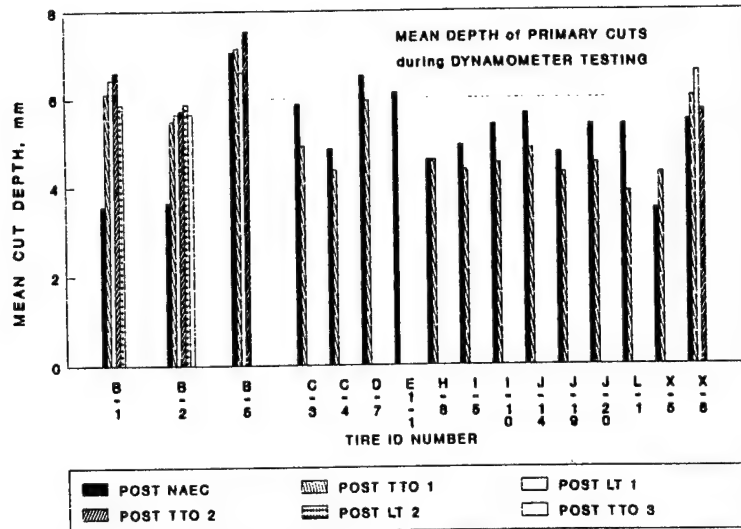
FIGURE 25: DEPTH CHANGES during TEST
New Tires

INDIVIDUAL CONDITION WITH TESTING - Changes in the mean cut depth of primary cuts of seventeen new tires are presented in Figure 25. No rational pattern can be drawn from this data. The same was true of the recapped tires.

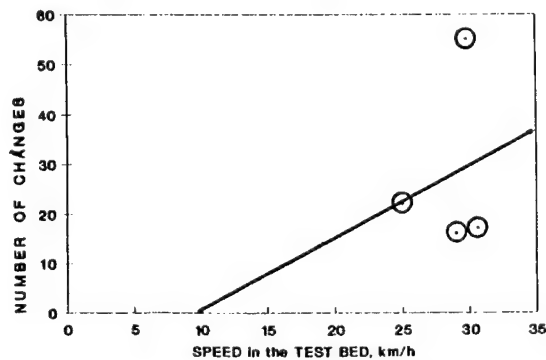
FIGURE 26: SPEED vs NUMBER of CUTS
Radial Tires

The number of primary cuts produced is presented in Figure 26, as a function of speed in the test bed at NAEC. The "newer" design H-1, 2, and 3 produced 2/3's fewer cuts than the "earlier" design H-4. Of the 110 primary cuts on all four tires POST NAEC, one half of the cuts were on H-4. Because of the small number of tires, run in a small speed range, there is not enough data to draw a useful conclusion.

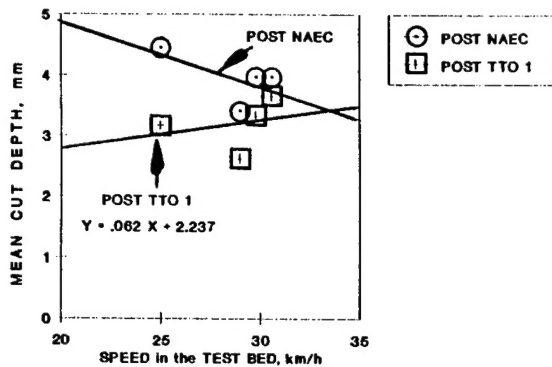
FIGURE 27: MEAN DEPTH OF PRIMARY CUTS
Radial Tires

The mean depth of cuts on each tire is presented in Figure 27. Unlike the production bias tires that were tested, these prototype radial tires did not have a Cut Limit label cast on the sidewall. The POST TTO 1 data shows the familiar positive slope and intercept with speed. If H-4 is removed from the data, the initial mean depth of all cuts in the other tires is 4.0 mm (5.036/32 inch).

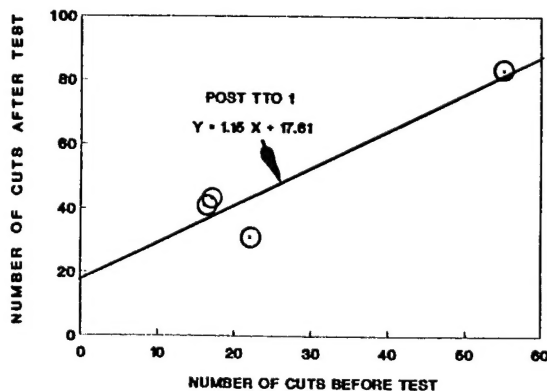
FIGURE 28: INCREASE IN NUMBER OF CUTS
Radial Tires

OVERALL CONDITION WITH TESTING - Data in Figure 28 suggests a 33% increase in number of cuts after TTO 1. This performance is similar to the new and recapped tires. POST LT 1 data is not available, as the radial tires were only remapped after TTO 1.

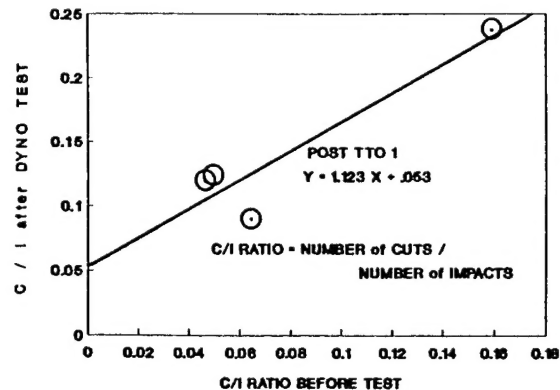
FIGURE 29: PERCENTAGE INCREASE IN CUTS
Radial Tires

In Figure 29, the data from Figure 28 is presented in a ratio of cuts per impact form. An increase of 18% is suggested. This is higher than the recaps, but lower than the new tires.

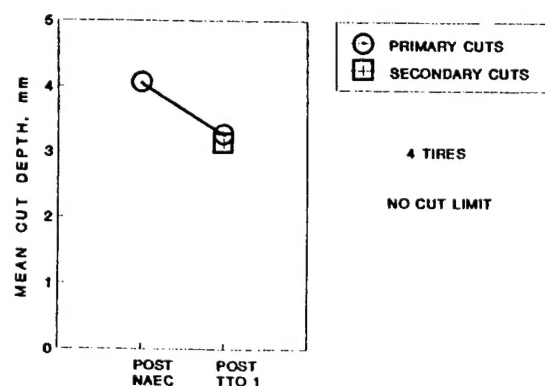
FIGURE 30: MEAN CUT DEPTH
Radial Tires

The mean depth of primary and secondary cuts of all tires is presented in Figure 30. The data population is very small, and no useful conclusions may be drawn.

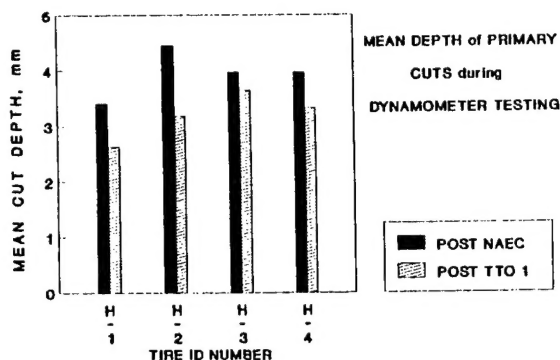
FIGURE 31: DEPTH CHANGES during TEST
Radial Tires

INDIVIDUAL CONDITION WITH TESTING - Changes in the mean depth of primary cuts of the four tires are presented in Figure 31, as each tire was tested on the dynamometer. All four experienced a reduction of depth with testing. No further maps were made after TTO 1, so no other data is available.

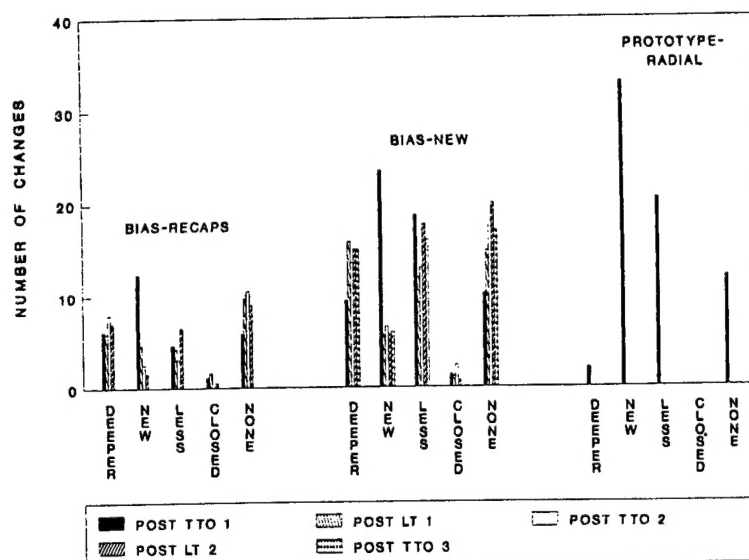
FIGURE 32: CUT ACTIVITY
during TESTING

As one may see in Figure 32, the three tire designs had different amounts of activity:

CUT DEPTH ACTIVITY - NEW cuts are indications of secondary damage. The number of new cuts is very high after the first taxi-takeoff segment. The activity then trails off greatly. The number of cuts that closed is very small throughout the tests. As was noted with the bias ply tires, the depth of the cuts increases with more test segments on the dynamometer.
